A FRONTAL IMPACT TEST OF A MIDAS GOLD CAR,  
FOR STEERING COLUMN DISPLACEMENT IN ACCORDANCE  
WITH ECE 12 AND EEC 74/297

MIRA TEST NO C78, CARRIED OUT ON 11 MARCH 1986

MIRA PROJECT NO K435500

Report No: K435500

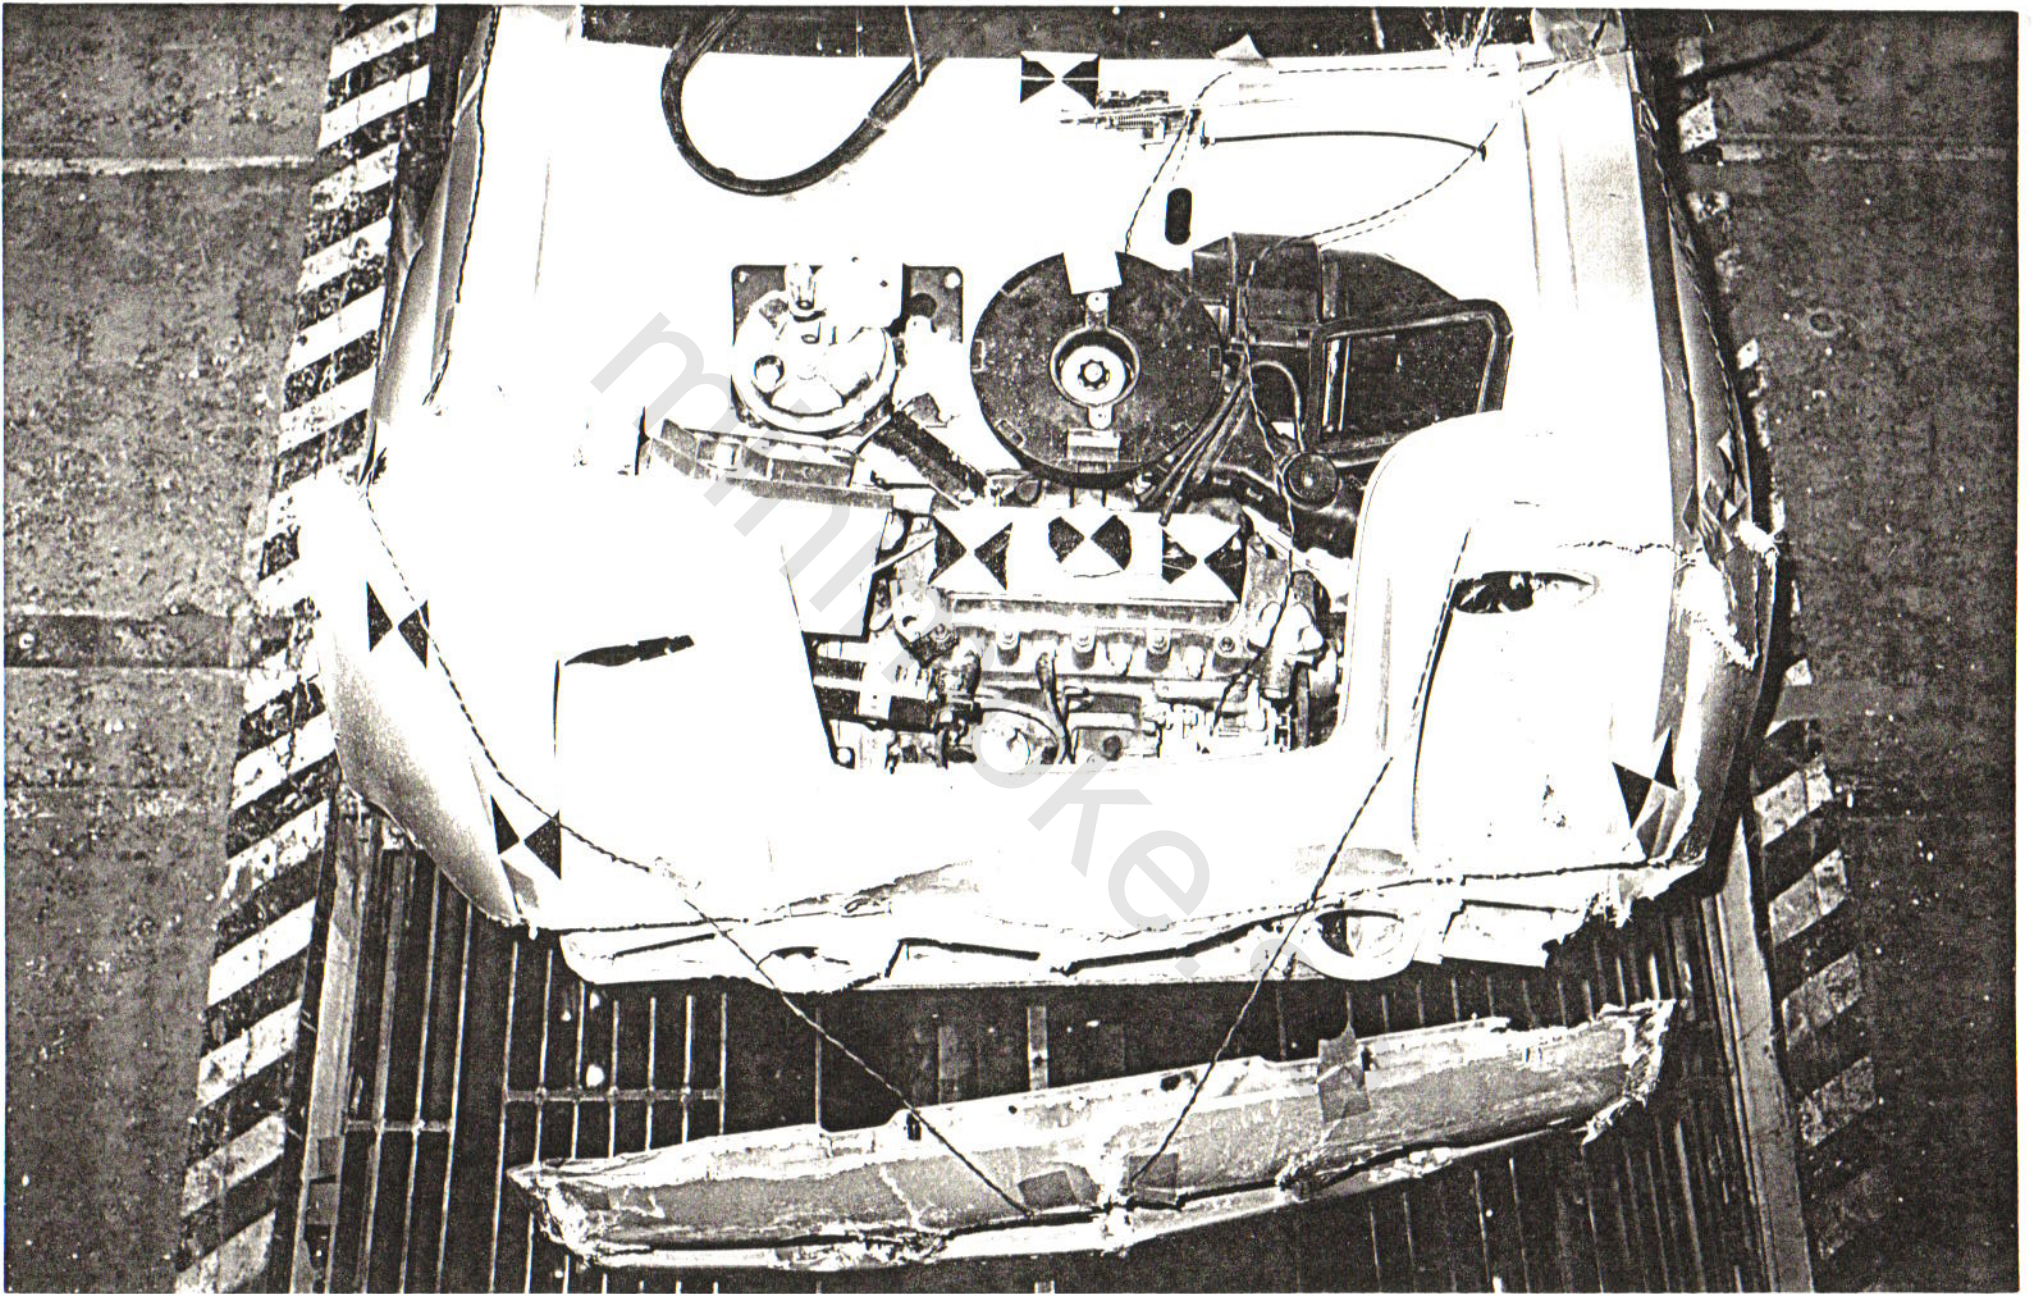
Plate 6 Front of the vehicle after the test

The crush of the vehicle, as measured by the reduction in length after the impact was 390 mm on the left side and 380 mm on the right side. The wheelbase had shortened by 80 mm on the left side and by 78 mm on the right side. The reduction in wheelbase was due almost entirely to the rearward displacement of the front wheels. The vehicle rebounded 800 mm from the face of the barrier.

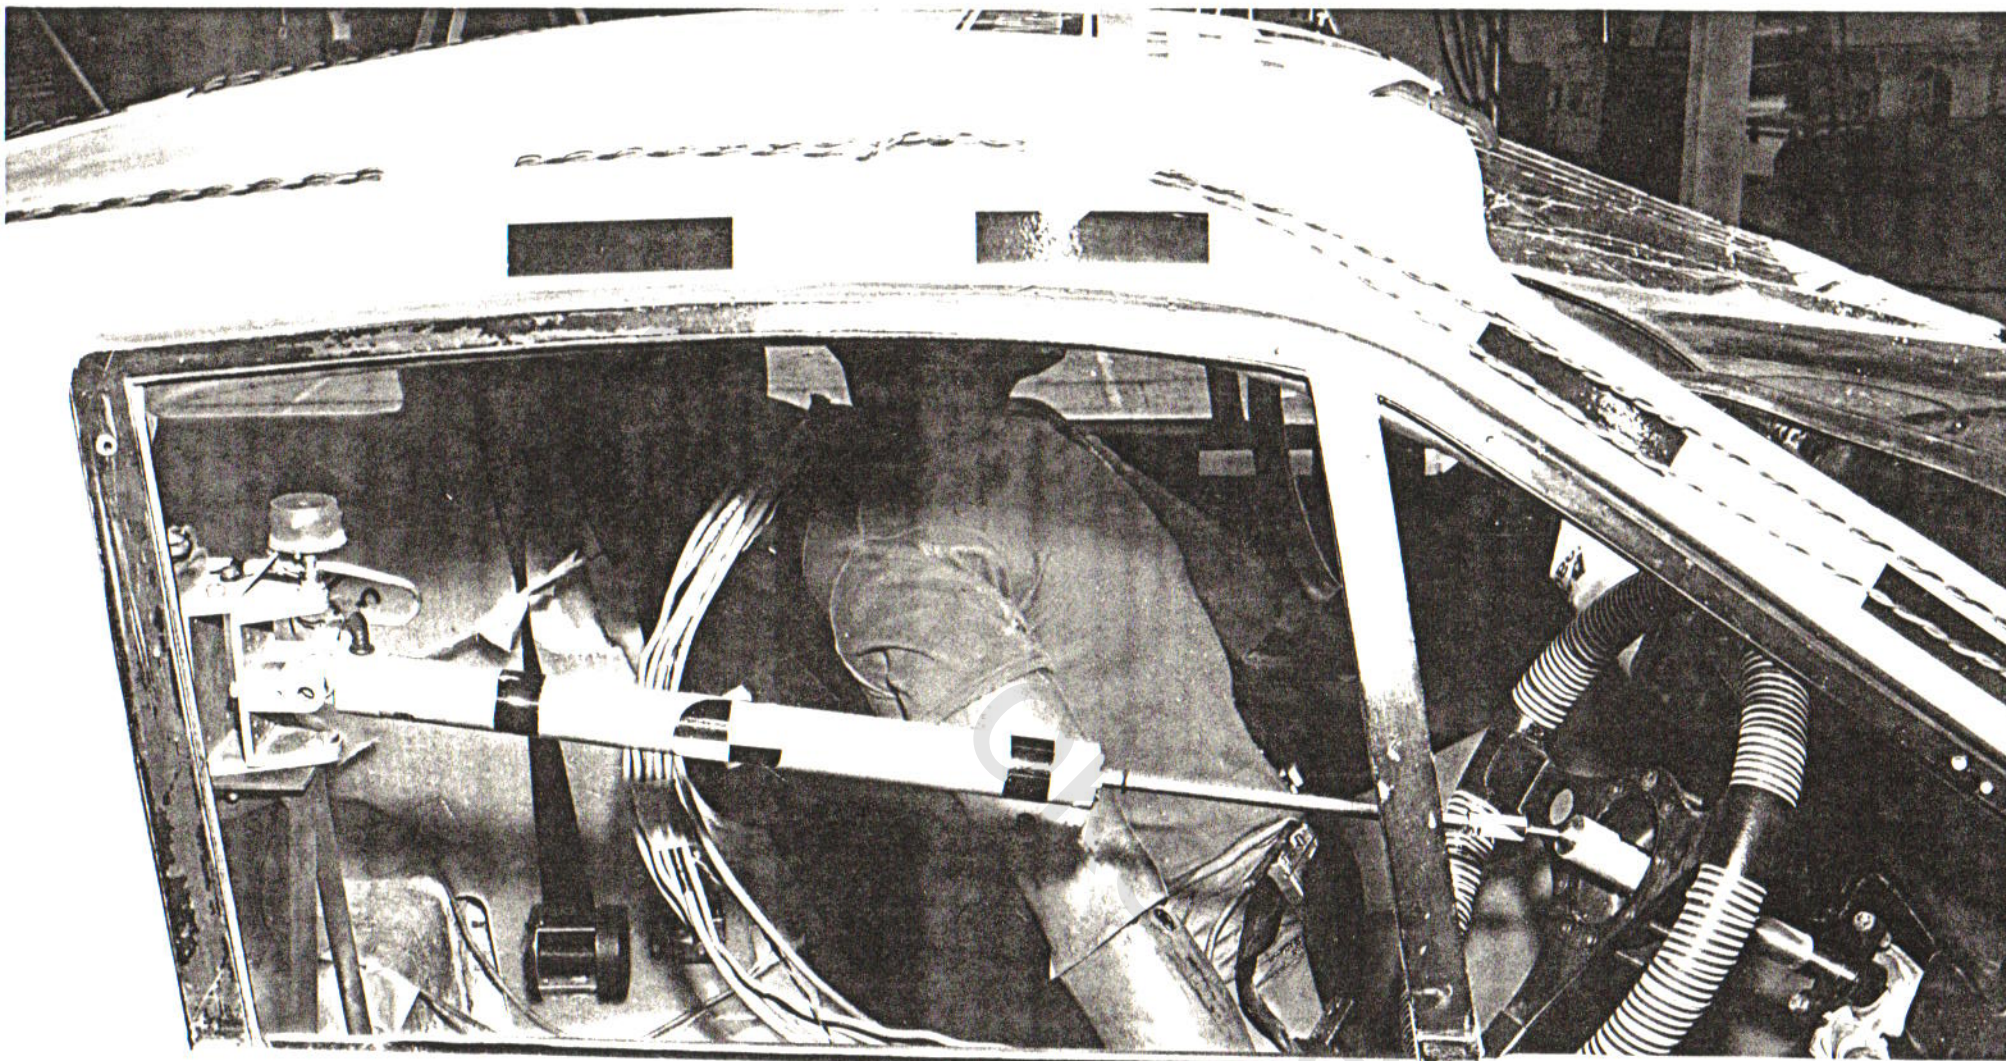
Plate 6 Steering column displacement transducer after the test

An inspection of the vehicle showed that the part of the vehicle on which the potentiometer platform was mounted had not been deformed by the impact.

The result shows a maximum rearward displacement of 15 mm, occurring at 39 ms. After the peak the dynamic displacement reduces, due to recovery of the structure. When measured manually after the test, the static displacement of the column was found to be 5 mm confirming the result obtained from the instrumentation.

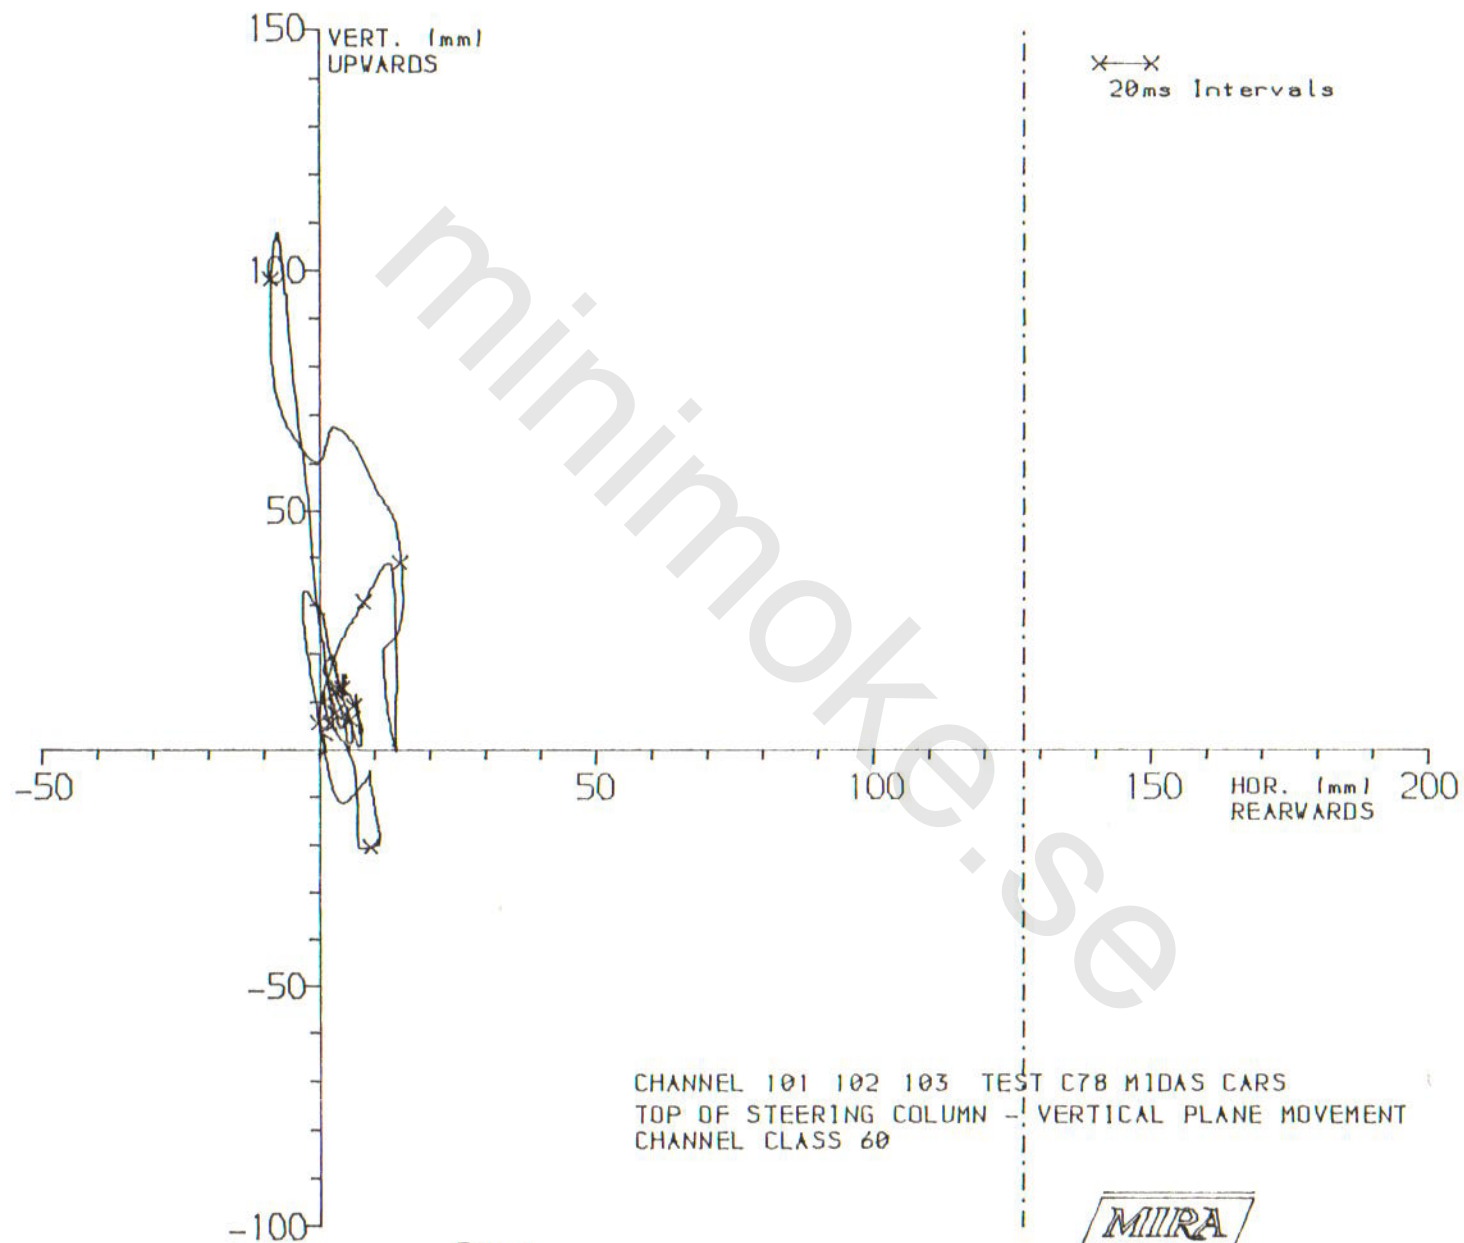
Fig 6

Figure 6 shows the vertical movement of the steering column, plotted against the horizontal movement as to give a locus in space. This is not required for legislation purposes.

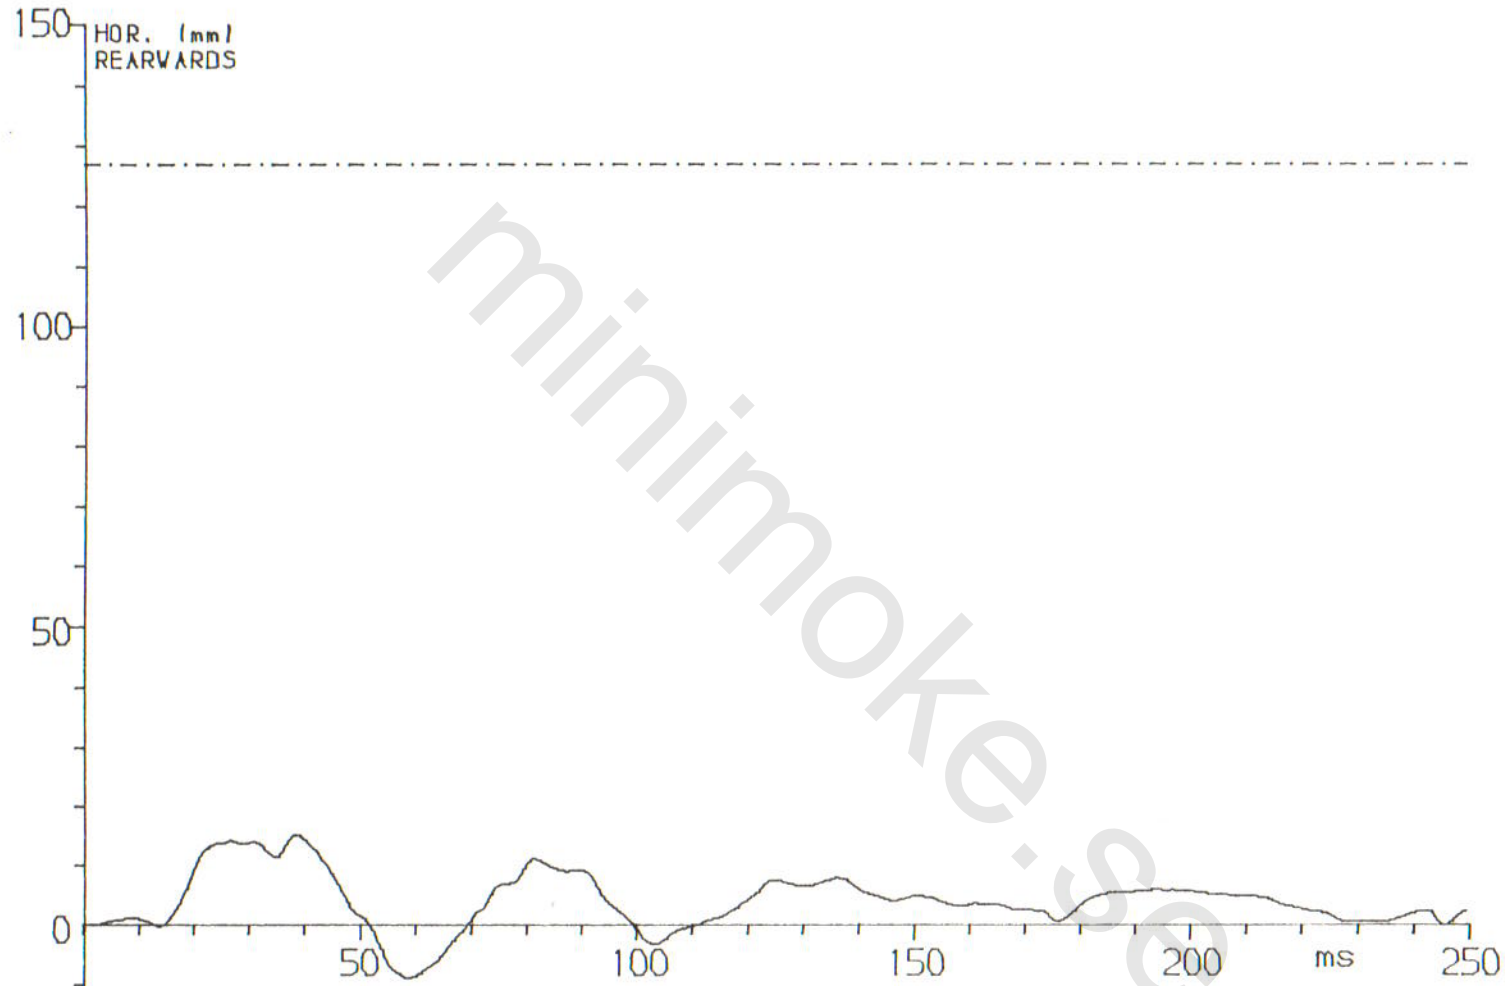
Fig 5

Figure 5 shows a computer generated graph of the rearward displacement of the steering column. This was calculated from the readings of the linear potentiometer and the two rotary potentiometers.

The peak horizontal displacement of the steering column was therefore less than the maximum of 127mm permitted by the two standards.

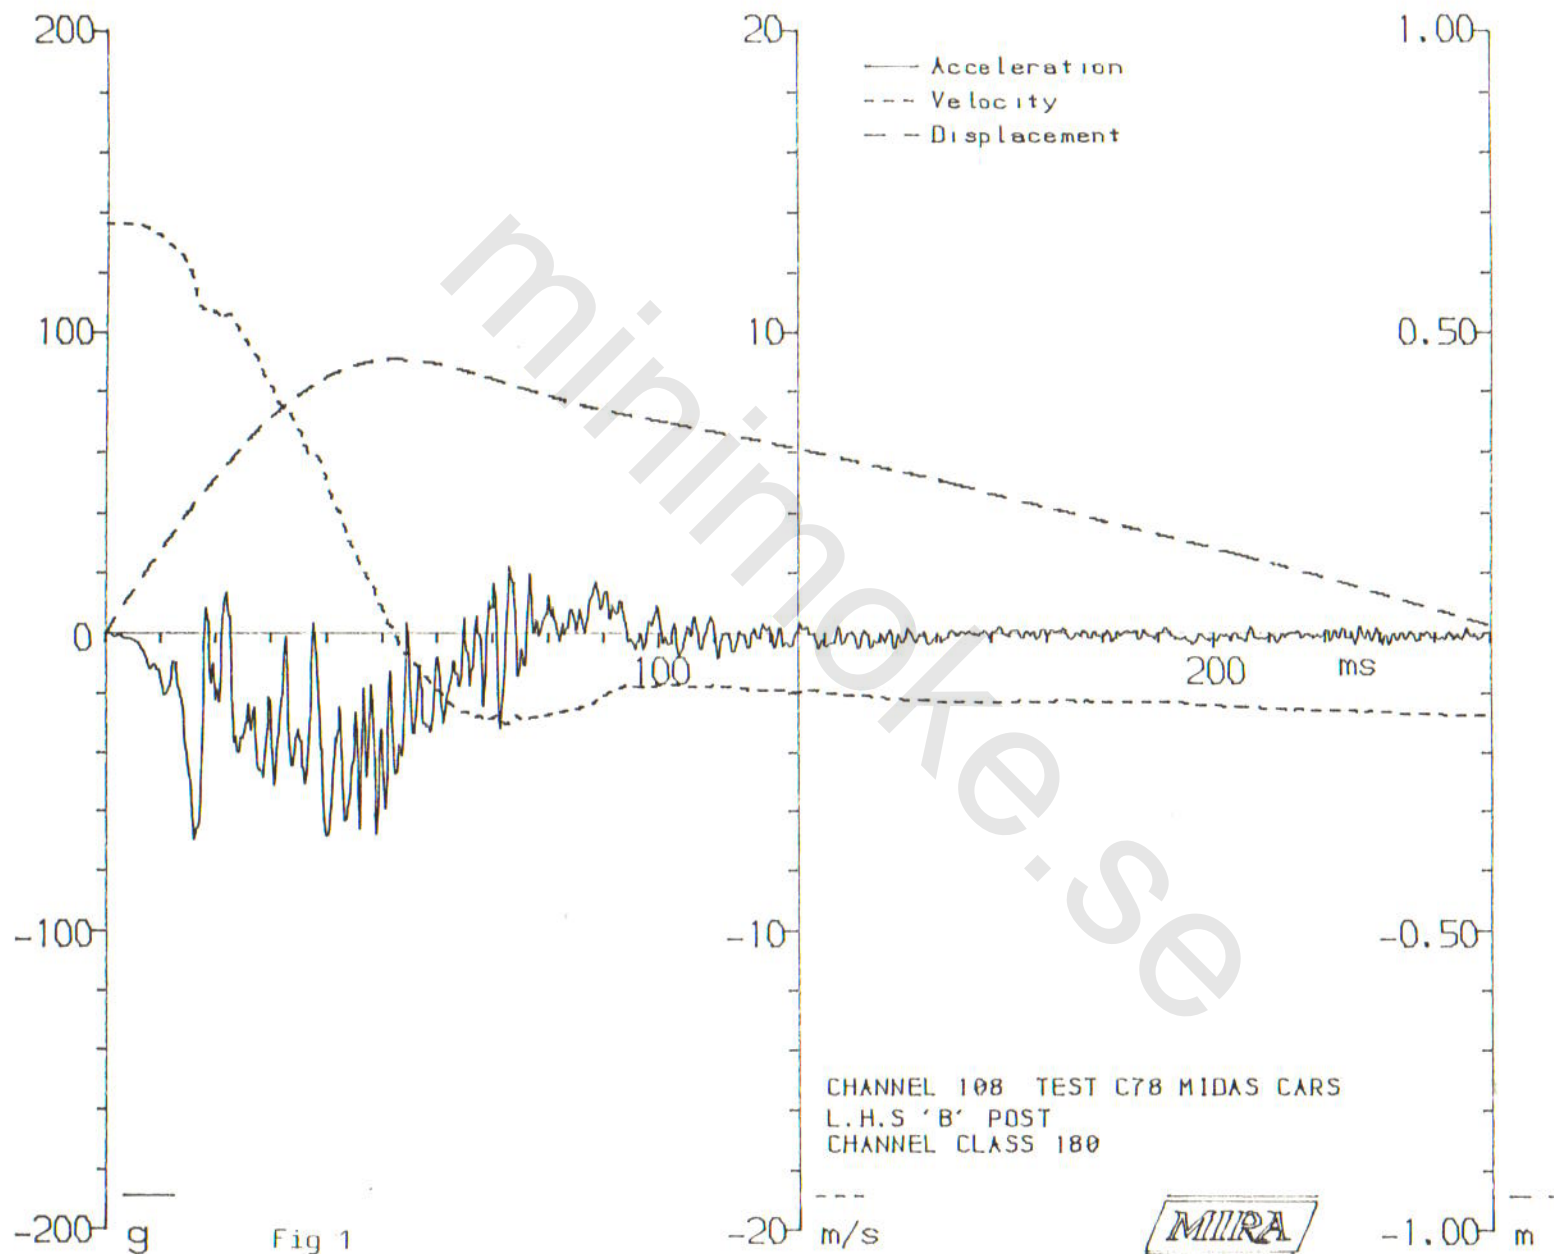
The deceleration of the main body structure of the vehicle may be seen in Figure 1. After reaching a peak of 69 g at 16 ms, the deceleration diminished to zero at 75 ms. Other deceleration histories can be seen in Figures 2, 3 and 4.
